**PRELIMINARY ASSESSMENT/
VISUAL SITE INSPECTION**

**DRAWN METAL PRODUCTS COMPANY
NILES, ILLINOIS
ILD 000 768 671**

FINAL REPORT

**U.S. ENVIRONMENTAL PROTECTION AGENCY
Office of Waste Programs Enforcement
Washington, DC 20460**

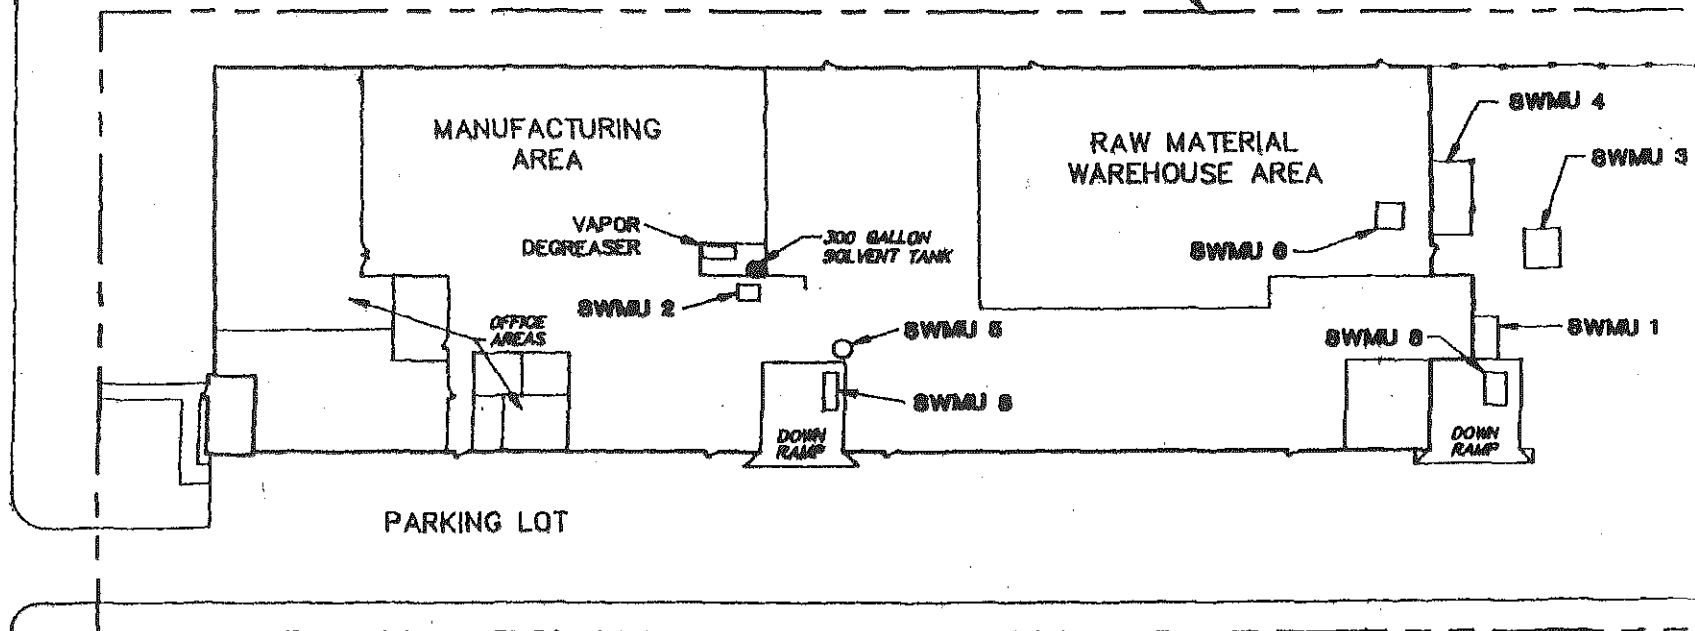
<u>SWMU NO.</u>	<u>SWMU NAME</u>
SWMU 1	HAZARDOUS WASTE CSA
SWMU 2	DISTILLATION SYSTEM
SWMU 3	WASTE OIL CSA
SWMU 4	FORMER WASTE CSA
SWMU 5	WASTE OIL ACCUMULATION AREA
SWMU 6	WASTE OIL STAGING AREA
SWMU 7	SCRAP METAL ACCUMULATION AREAS
SWMU 8	SCRAP METAL STORAGE AREAS

NOTE: Scrap Metal Accumulation Areas (SWMU 7) are located throughout the facility

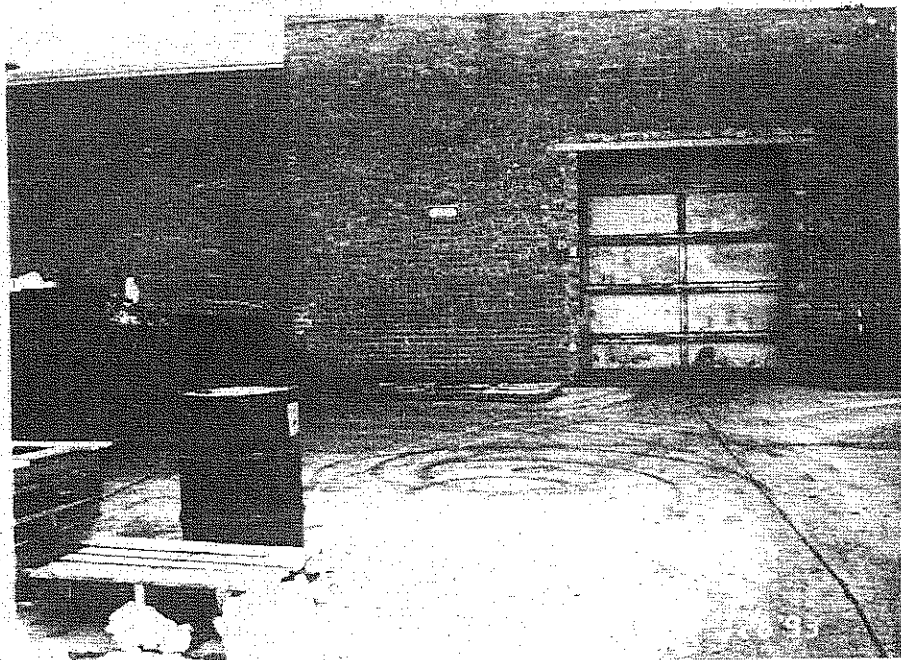
Photograph No. 1

shovelled after heavy snowfall during the previous week. The area around the unit consists of a concrete pad, which is surrounded by an asphalt area. No cracks in the concrete pad or visible evidence of spills were observed (see Photographs No. 1 and 2).

Description: Hazardous Waste CSA containing three wooden pallets; the area south of the unit contained one 55-gallon drum of still bottoms containing TCE (F002); according to the facility representative, the 55-gallon drum was temporarily stored outside the unit because the unit had recently been shovelled after heavy snowfall during the previous week; area is surrounded by asphalt

Recommendations: PRC recommends no further action for this SWMU at this time.

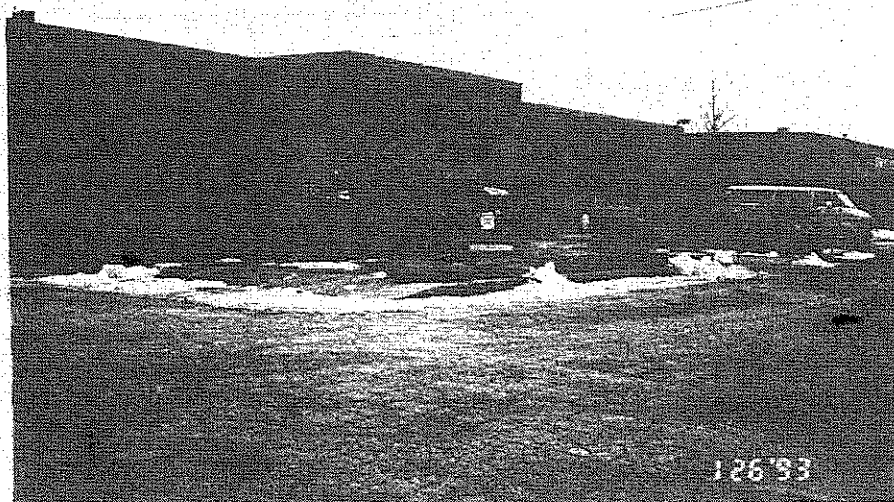
Photograph No. 2

Observations: The unit contained 10 55-gallon drums of nonhazardous waste oil during the VSI. The area around the unit is asphalt. No cracks in the concrete pad or visible evidence of spills were observed (see Photographs No. 2 and 4).

Description: Area south of the facility that consists of the Hazardous Waste CSA, the Waste Oil CSA, the Former Waste CSA, and one of the Scrap Metal Storage Areas

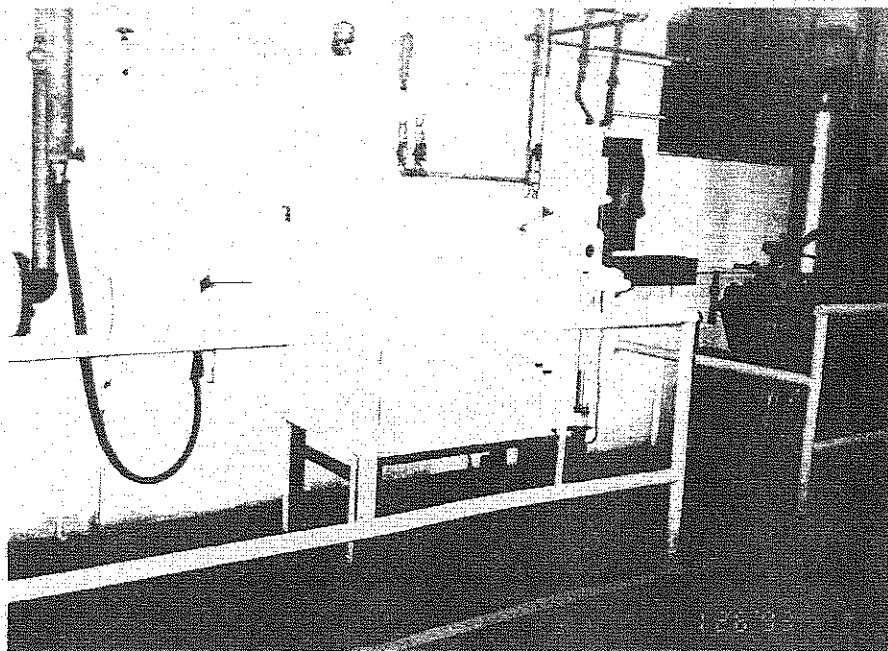
Photograph No. 3
 Orientation: Southeast
 Description: Distillation System

Observations: The unit contained about 75 gallons of spent TCE during the VSI. No cracks in the concrete floor or visible evidence of spills were observed (see Photograph No. 3).

Recommendations: PRC recommends no further action for this SWMU at this time.

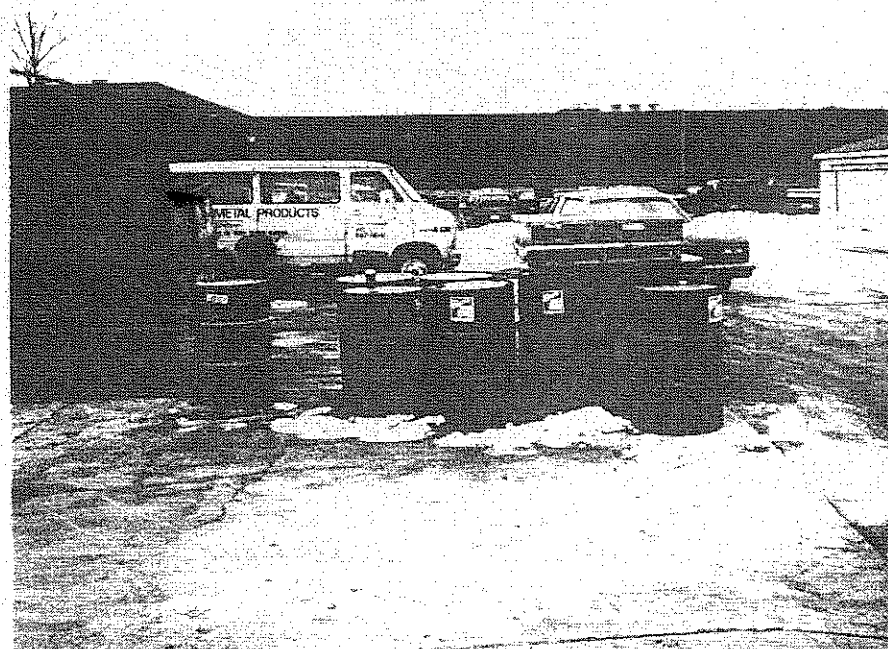
Photograph No. 4
 Orientation: East
 Description: Waste Oil CSA containing 10 55-gallon drums of nonhazardous waste oil; area around the unit is asphalt

PRC recommends no further action for this SWMU at this time.

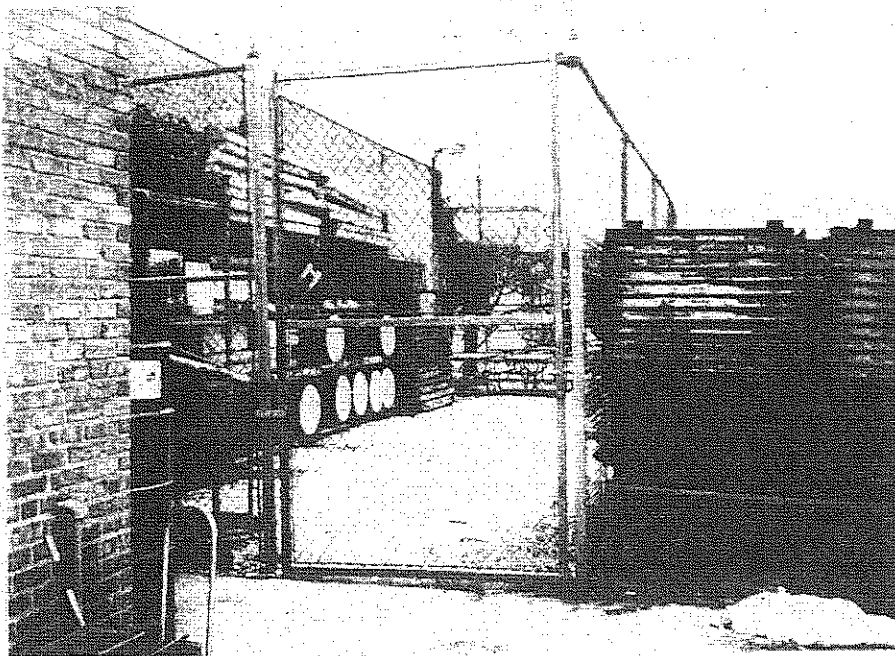
Photograph No. 5

Observations:	The unit contained about seven empty 55-gallon steel drums during the VSL. PRC noted no stains on the soil or evidence of spills. The area around the unit is a concrete pad to the west and southwest and asphalt to the south and east (see Photographs No. 2 and 5).
SWMU 5	Waste Oil Accumulation Area
Unit Description:	This unit is indoors in the central portion of the facility and consists of a 55-gallon steel drum on a concrete floor. The unit measures about 4 by 4 feet and operates as an accumulation area for nonhazardous waste.
Date of Startup:	According to facility representatives this unit began operating in late 1956, when facility operations began.
Date of Closure:	This unit is active.

Description: Former Waste CSA containing seven empty 55-gallon steel drums; PRC noted no stains on the gravel or evidence of spills during the VSI; area around the unit is a concrete pad to the west and southwest and asphalt to the east and south

PRC recommends no further action for this SWMU at this time.

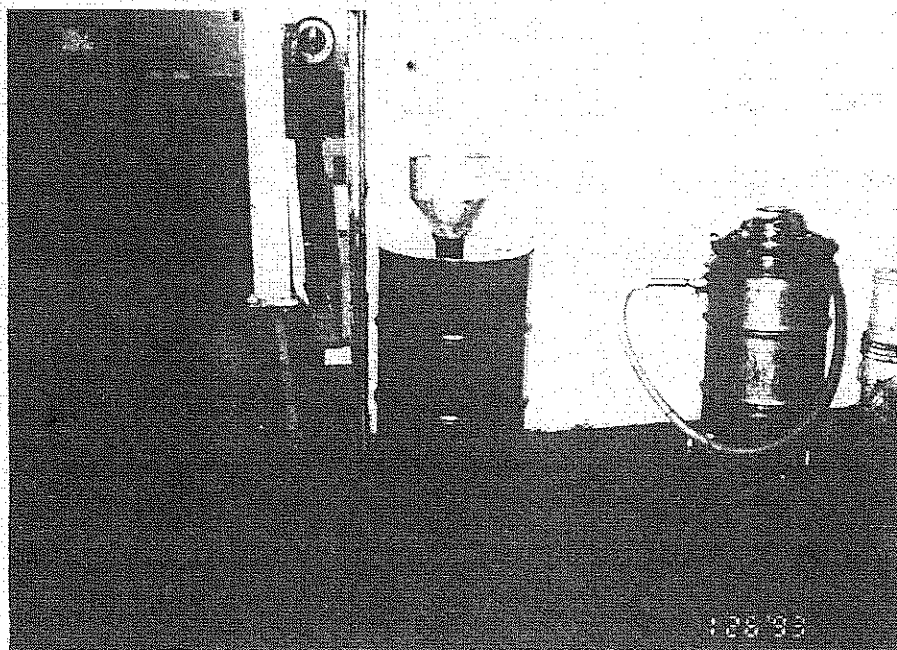
Photograph No. 6

Observations: The unit contained one partially full, 55-gallon steel drum of nonhazardous waste oil during the VSI. The unit is next to the dock area. No cracks in the concrete floor or visible evidence of spills were observed (see Photograph No. 6).

PRC recommends no further action for this SWMU at this time.

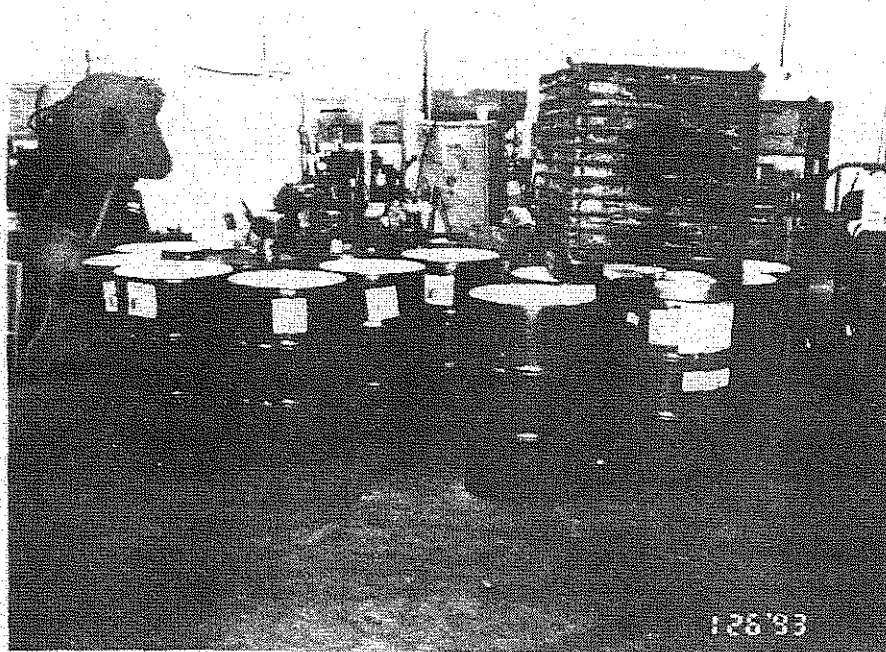
Observations: The unit contained 14 55-gallon drums of waste oil during the VSI. No cracks in the concrete floor or visible evidence of spills were observed (see Photograph No. 7).

Photograph No. 7
 Orientation: South
 Description: Waste Oil Staging Area containing 14 55-gallon drums of waste oil

Recommendations: PRC recommends no further action for this SWMU at this time.

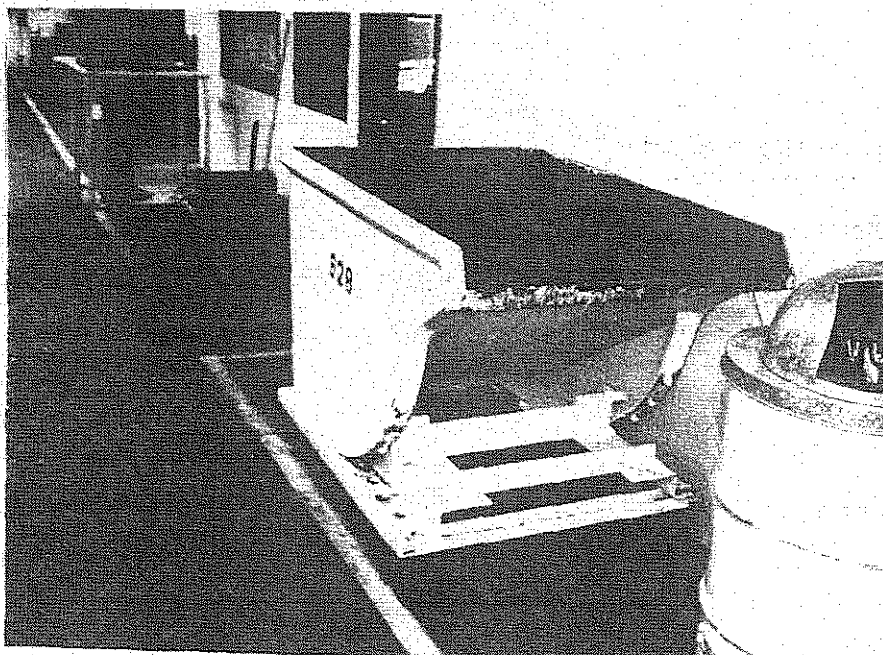
Observations: The unit contained about 1 cubic yard of scrap metal during the VSI. The scrap metal in the unit was covered with nonhazardous waste oil. No cracks in the concrete floor or visible evidence of spills were observed (see Photographs No. 8 and 9).

Photograph No. 8
 Orientation: South
 Description: One of the Scrap Metal Accumulation Areas with a 1- to 2-cubic-yard container

Recommendations: PRC recommends no further action for this SWMU at this time.

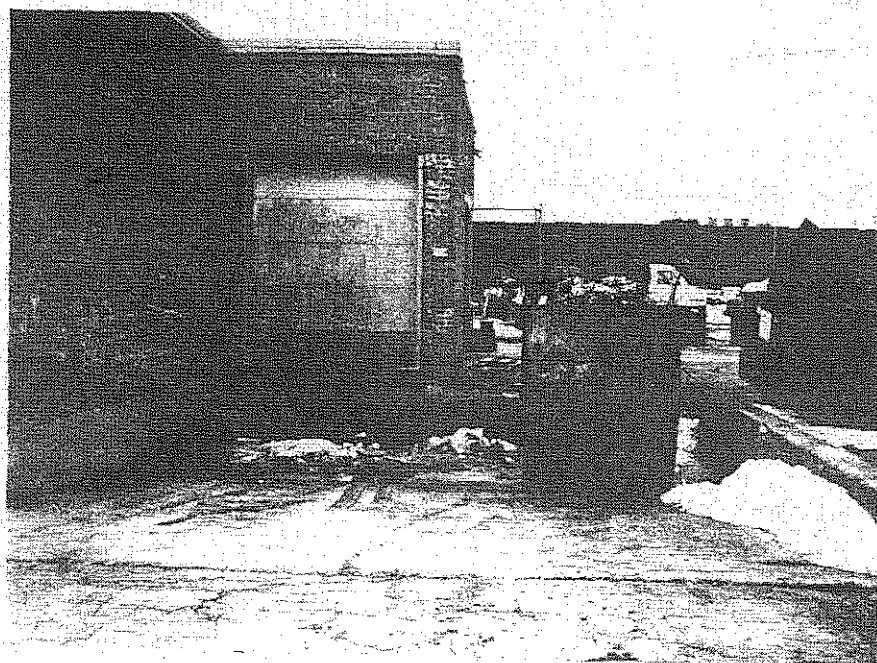
Photograph No. 10

Observations: The unit contained about 8 cubic yards of scrap metal in each roll-off box during the VSI. PRC noted some cracks in the concrete pad. Also, nonhazardous waste oil stains were observed on the concrete pad and on the facility's outside wall (see Photographs No. 10 and 11).

Description: Scrap Metal Storage Area with nonhazardous waste oil stains on the concrete pad and on the facility's outside wall

Recommendations: PRC recommends no further action for this SWMU at this time.

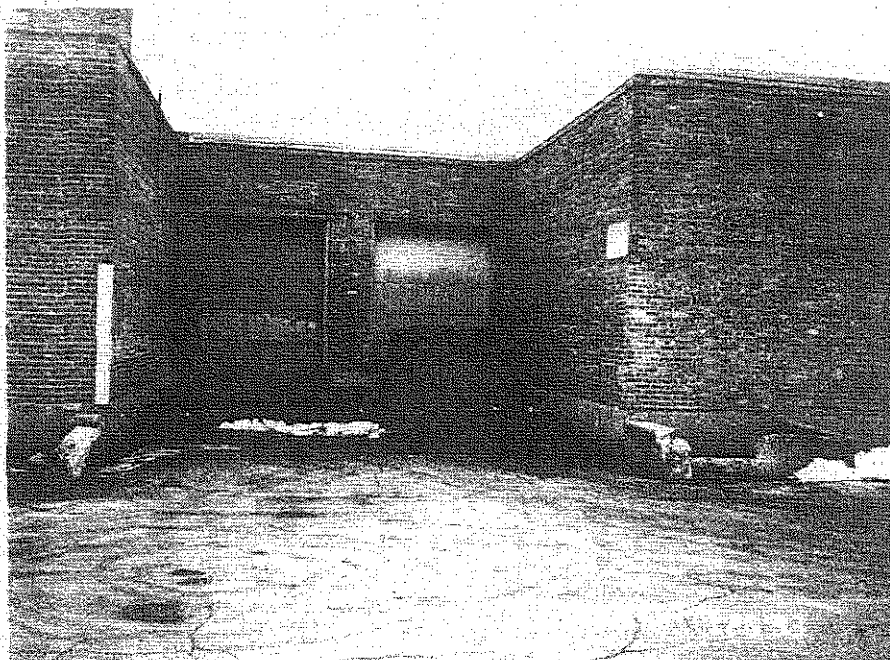
Photograph No. 1

Description: Scrap Metal Storage Area with nonhazardous waste oil stains on the concrete pad and on the facility's outside wall
